# Manhole Inspection Summary

Manhole # S65G\_\_002MH

Insp Date: **3/14/08 11:23 AM**

**Location** Address: **400 Folcroft St.**

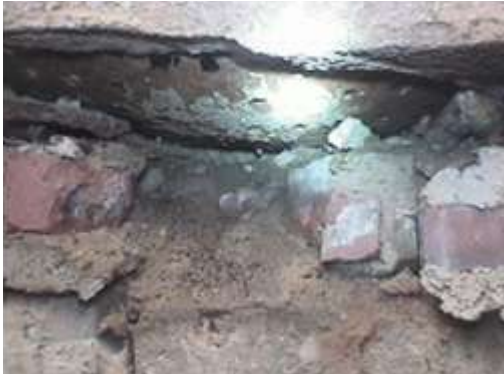
Defect 2

Condition: ☐ Sound ☐ Cracked ☐ Root Intrusion ☒ **Loose Brick** ☒ **Deteriorated**

Infiltration: ☐ None ☒ **Joint** ☐ Cracks ☒ **Mortar** ☐ Roots ☒ **Wall**

Missing bricks and signs of infiltration in chimney.

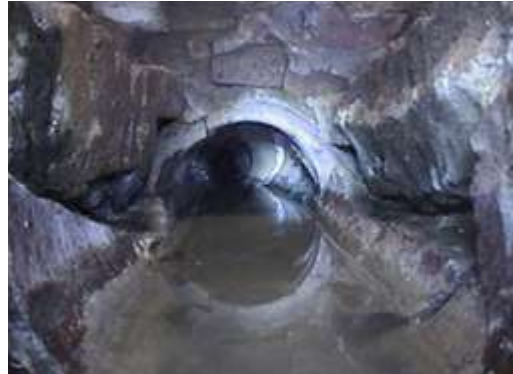
Defect 3

Condition: ☐ Sound ☒ **Cracked** ☐ Root Intrusion ☒ **Deteriorated** ☐ Leaks ☐ Debris

Deteriorated channel, fracture circumferential 3:00-7:00

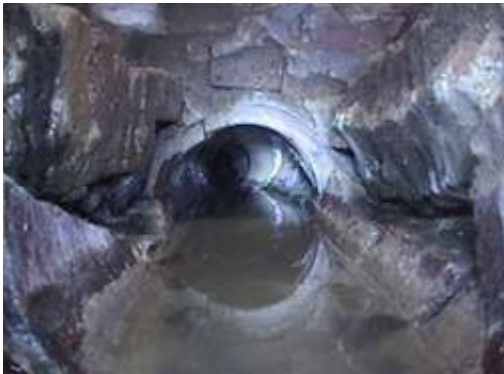
Defect 1

Cracked pipe 11:00.

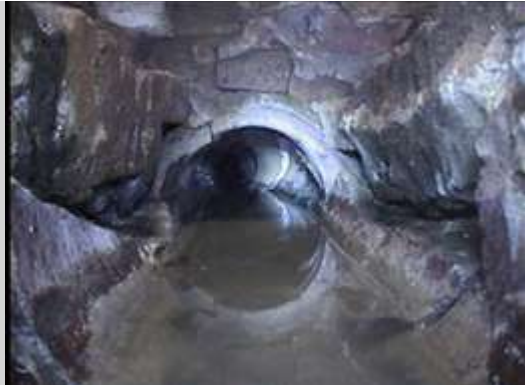
12 O'Clock Outflow

8 in. Circular Gravity Sewer  
Pipe Out @ 12 O'Clock

Pipe Height: **8.4** (in.) Rod and Bar (Angled)  
Pipe Material: **Clay** ☐ Pipe Lined  
Invert Depth: **8.63** (ft.) Flow Characteristics: **Slow**  
Deposits: ☒ None ☐ Mud ☐ Sludge ☐ Debris ☐ Grease  
Silt Depth: (in.) Deposits Extent:  
Infiltration: **None** Pipe Seal Cond: **Cracked**
